# **Historic Building Assessment for The Audubon Society of New Hampshire's Ash Cottage**

**50 North Shore Road, Hebron, New Hampshire**

Completed December 10, 2021

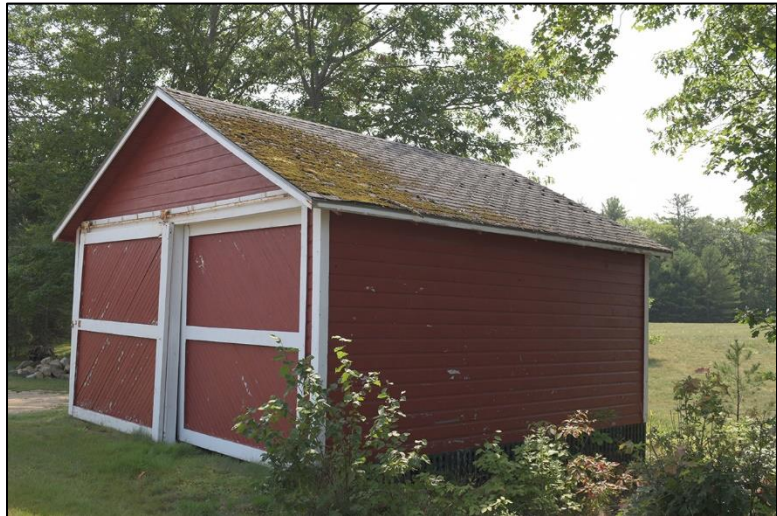
- Outbuildings: The Ash Cottage garage is in generally good to fair condition. Though the building does not seem to leak currently, the asphalt roof is beginning to peel and there is a significant amount of vegetative growth on the north slope, beneath overhanging trees (Figure 43). Some of the barn hardware on the doors is beginning to rust, and the door handle is detached and is currently on the ground. There are areas throughout the exterior of the garage where the paint (particularly the red) is peeling.

Figure 43: Garage, from northwest

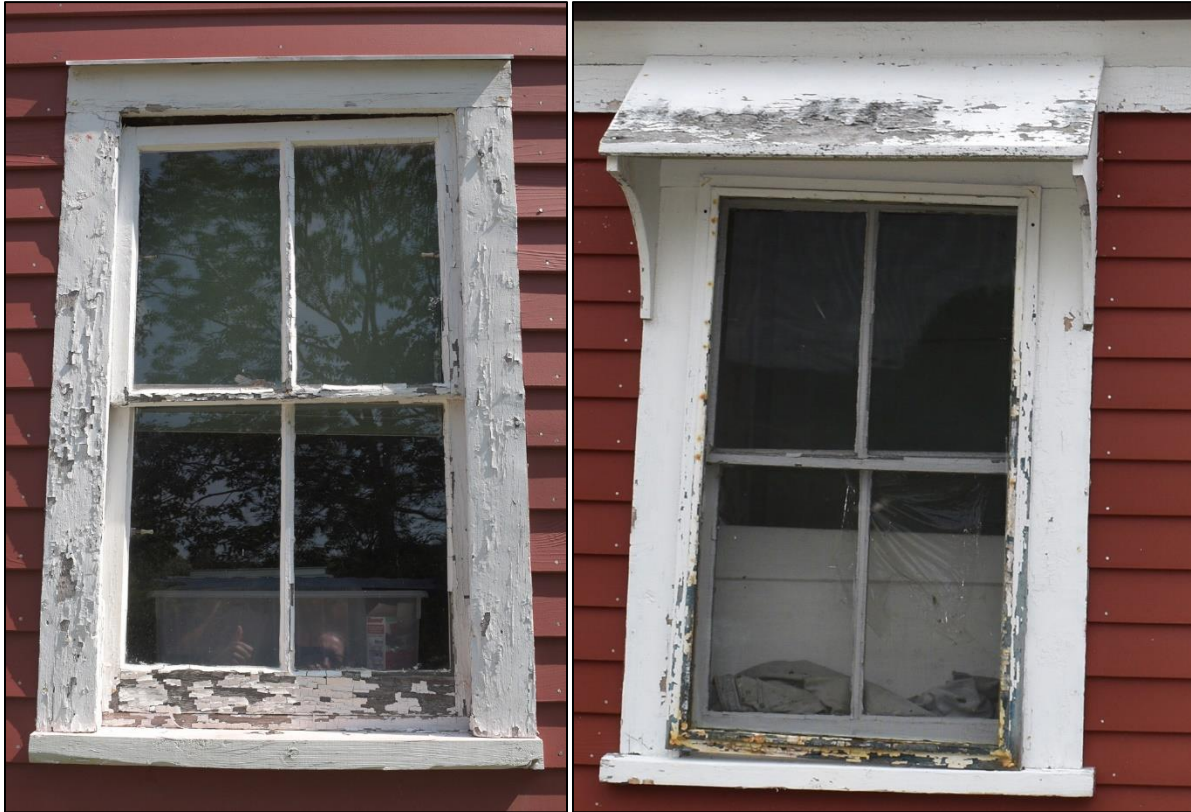
- Exterior Wall Cladding: The new (2019) exterior wall cladding of the building is in good condition. The clapboards appear to be holding paint well, and there were no noted areas of concern.
- Windows: The two-over-two windows throughout are in fair condition. The sash does not move easily, and there are several locations with cracked panes (Figures 44 & 45). The frame of the single-light

*Figures 44 & 45: Typical windows showing signs of miss-alignment, cracked panes, and paint-loss*

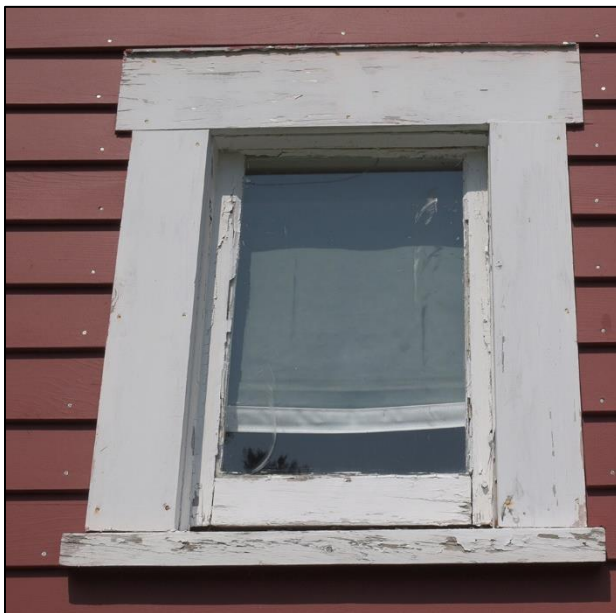
bathroom window in the south ell is starting to come apart (Figure 46). There are also no exterior storms to protect the historic sash. The windows have never been fully restored, and are assumed to contain lead paint, as is universal for windows of this period. The window frames are in generally good condition, though they were noted to have extensive areas of paint loss throughout.

*Figure 46: Damaged south window of south ell*

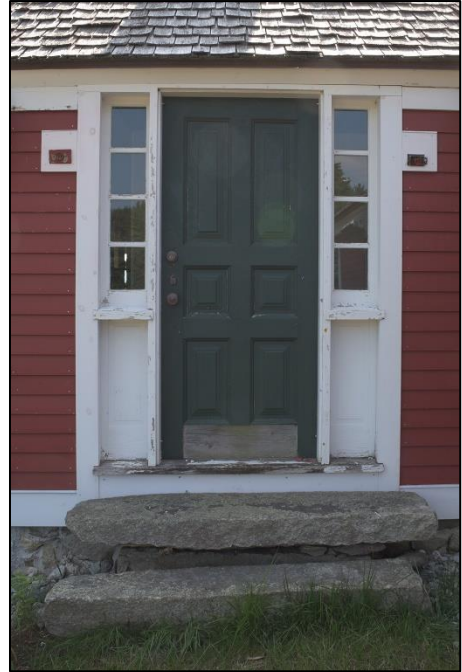
- Exterior Doors: The exterior doors at Ash Cottage are in generally good condition with areas of peeling paint. The bottom rail of the front door is peeled entirely, and the threshold is rather water-logged (Figure 47). The granite steps outside this door are not quite centered, and there is a considerable void beneath the top step which may create a trip hazard. Though the paint of the screened door to the east wing addition (kitchen) is very peeled, the exterior door at this location is in good condition.

Figure 47: Front entrance

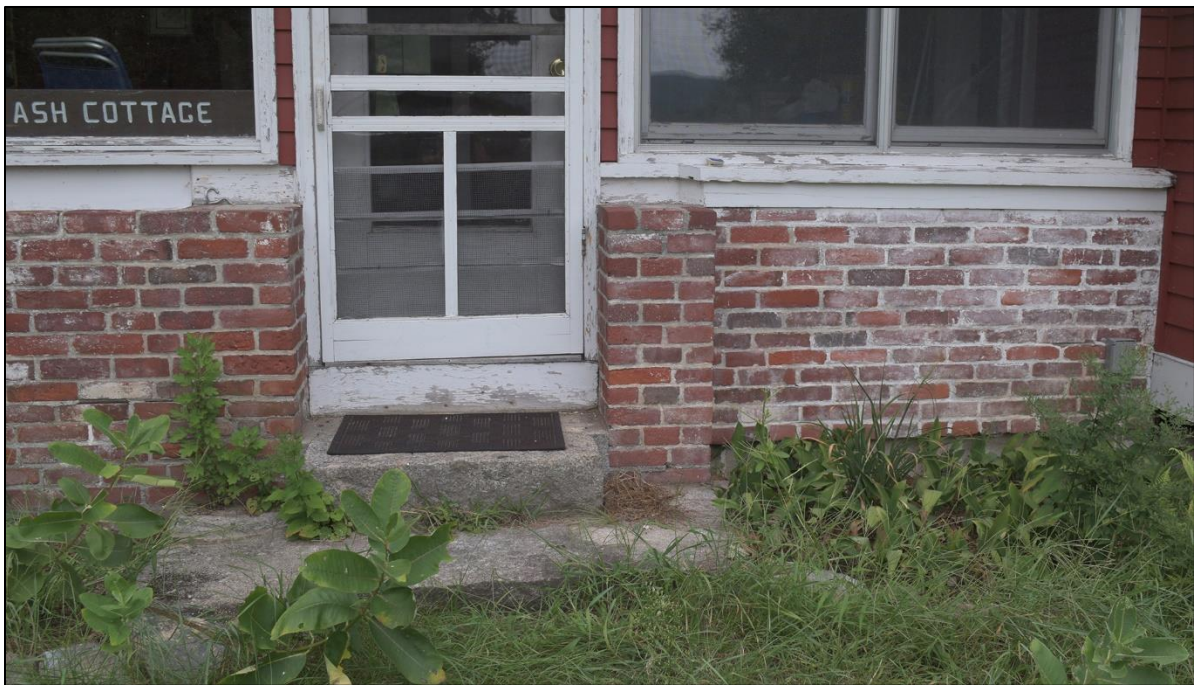
NH Audubon uses the 1963 sun room entrance as the primary entrance to the building (Figure 48). The screen and exterior doors at this entry are also in good condition, however, this entrance is also up a set of granite steps. None of the entrances to the building are barrier-free.

Figure 48: Sun room entrance (primary entrance used by NH Audubon)

- **Brick Porch Walls:** The brick walls around the 1963 sun room are in fair condition. Several areas along the exterior of these walls appear to have white “paint” across the surface (Figure 48). The light substance is actually mortar residue left on the surface of the brick during a previous attempt to patch the mortar without properly cleaning the brick after the application of new mortar.

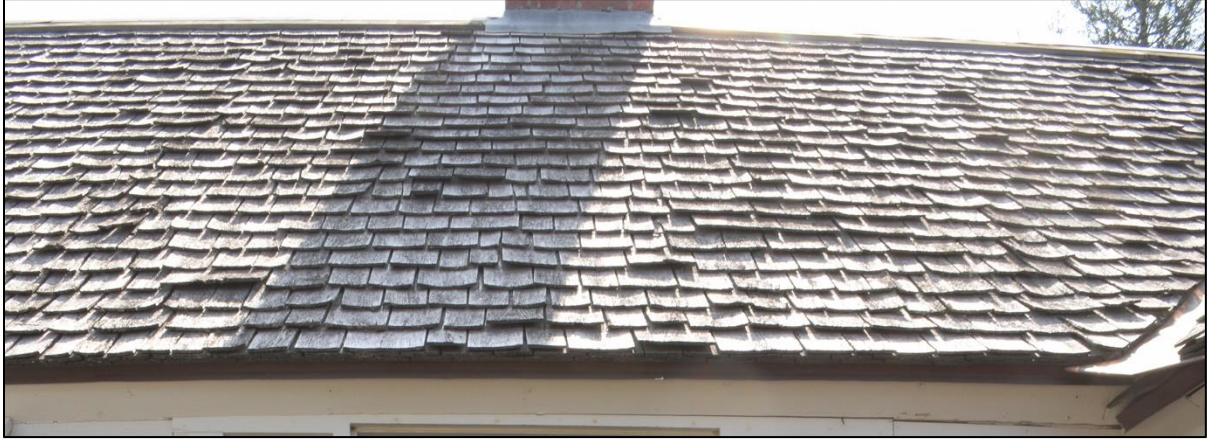
*Figure 49: Shingle roof, north slope main block*

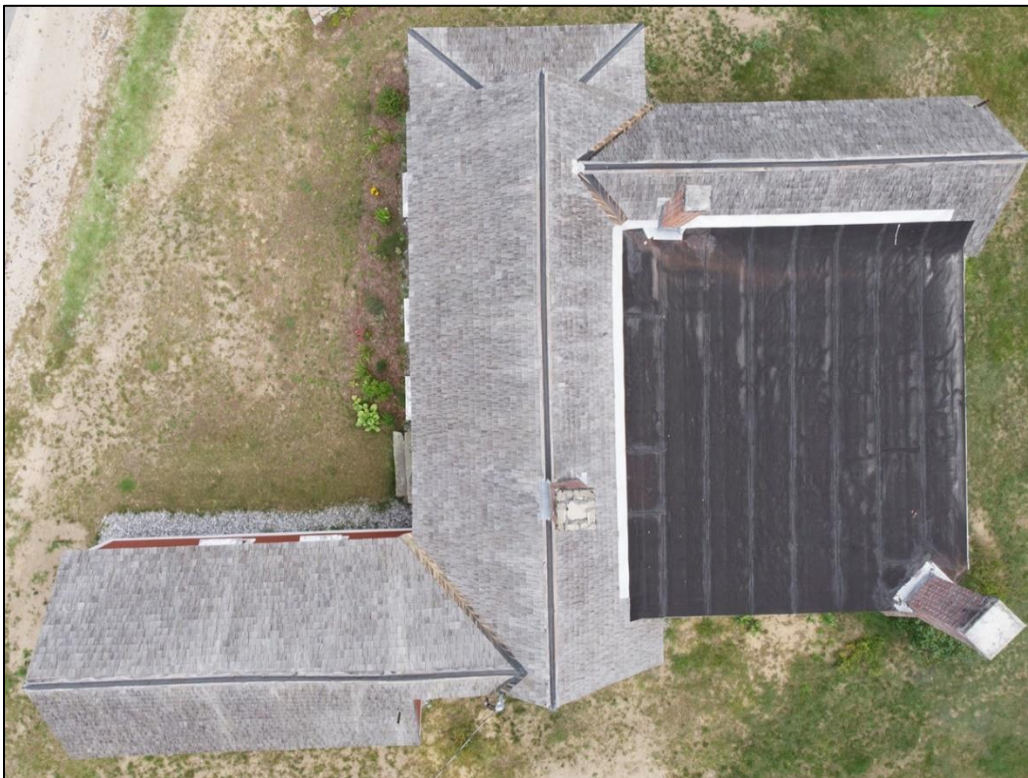
The roof sheathing is in generally good condition. The copper flashing at the chimneys and valleys of the gable roof section appears to be well-maintained and adequate. The wood roofing shingles are in good to fair condition, with several shingles that have curled up or broken (Figure 49). The sheet material at the roof of the sun room is in fair condition and is being to show signs of UV degradation, suggesting it is nearing the end of its life (Figure 50).

*Figure 50: Ash Cottage from above (north is left)*

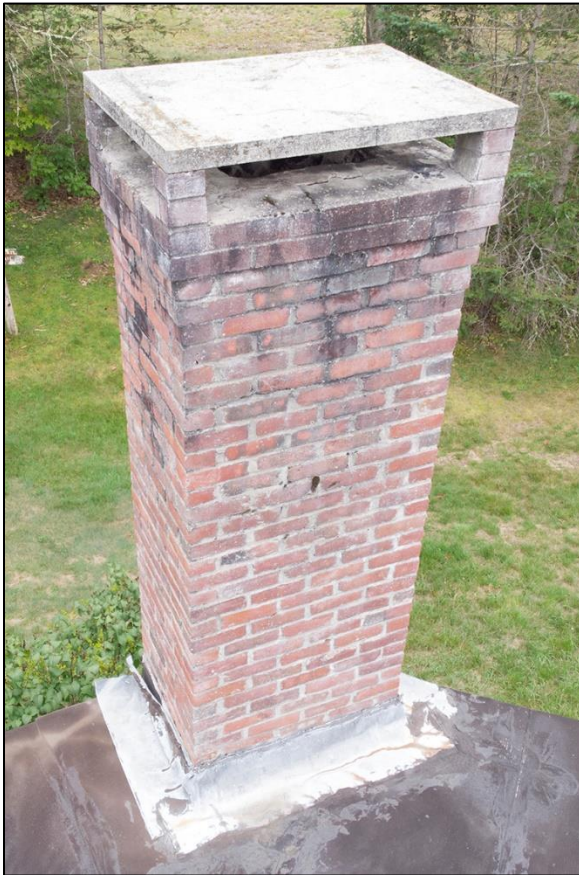
Figure 52: Sun room chimney

The 1963 angled corner chimney is in fair condition (Figure 52). Several of the bricks have spalled, and there are significant areas of mortar loss near the cap. A large section of flashing at the south side has become detached, and there are signs of previous attempts to repair the flashing that have failed.

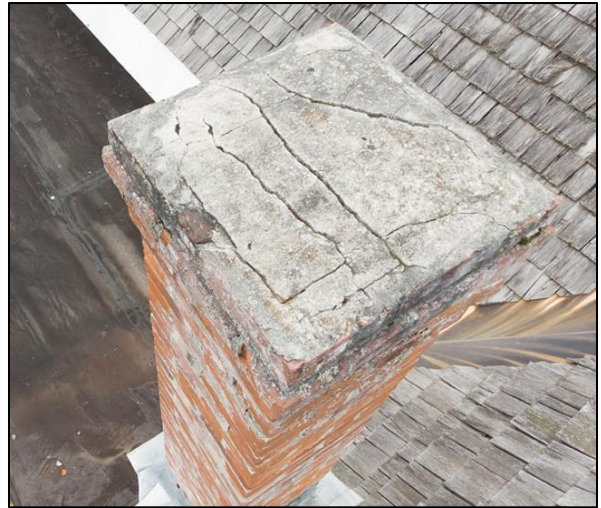
The south ell stove chimney is in similar condition, with some mortar loss near the corbeled top and fissures developing in the concrete “plug” (Figure

Figure 51: South ell chimney from above

51). Like the main chimney, there is evidence of some brick spalling within the attic level.

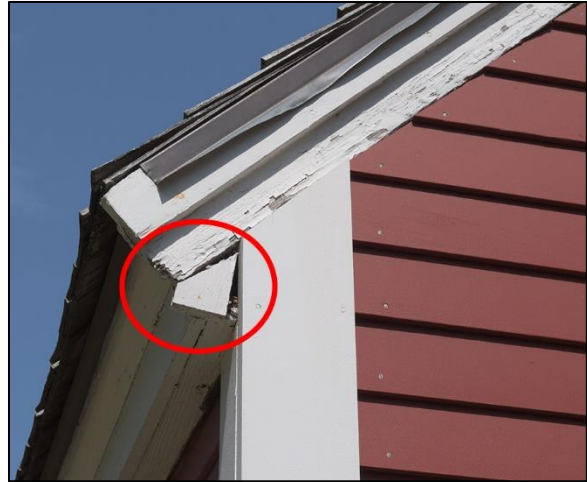
- Fascia, Trim, Soffits & Overhangs: Overall, the exterior trim at Ash Cottage is in good condition, despite some areas of peeling paint. Some of the historic trim was replaced as part of the 2019 re-siding project. There are a few locations, specifically at the ends of the eave trim, where there is damage to some of the ends of the boards or small pieces of wood that have become loose (Figure 53). Many of the window surrounds also have significantly peeling and flaking paint.

Figure 53: Damage to eave trim

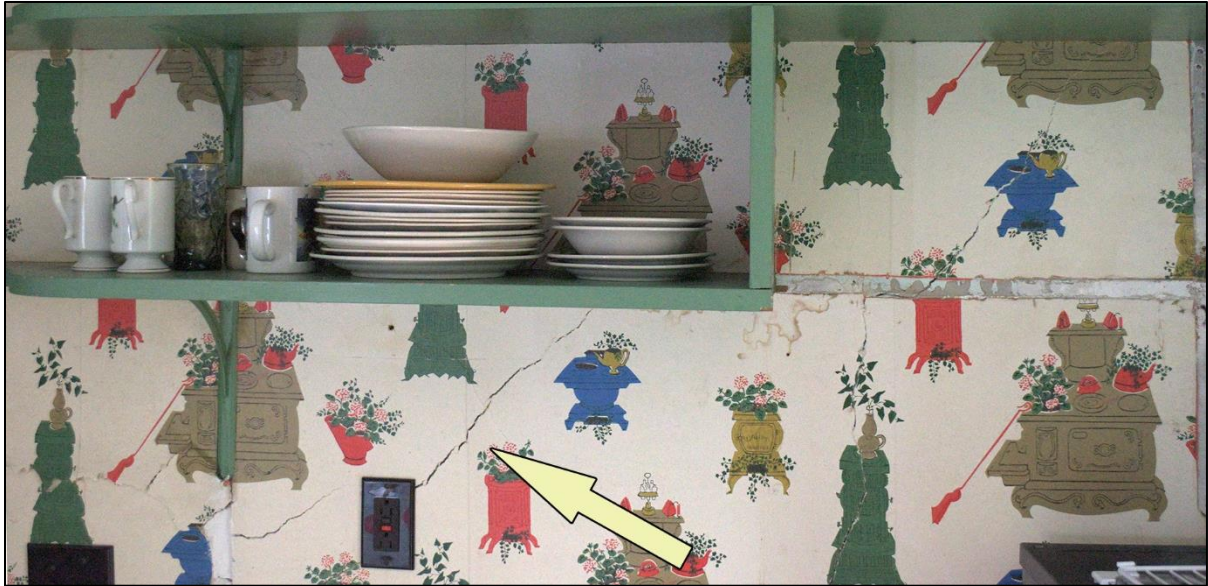
Figure 54: Plaster cracks in east wall of east wing addition (kitchen)

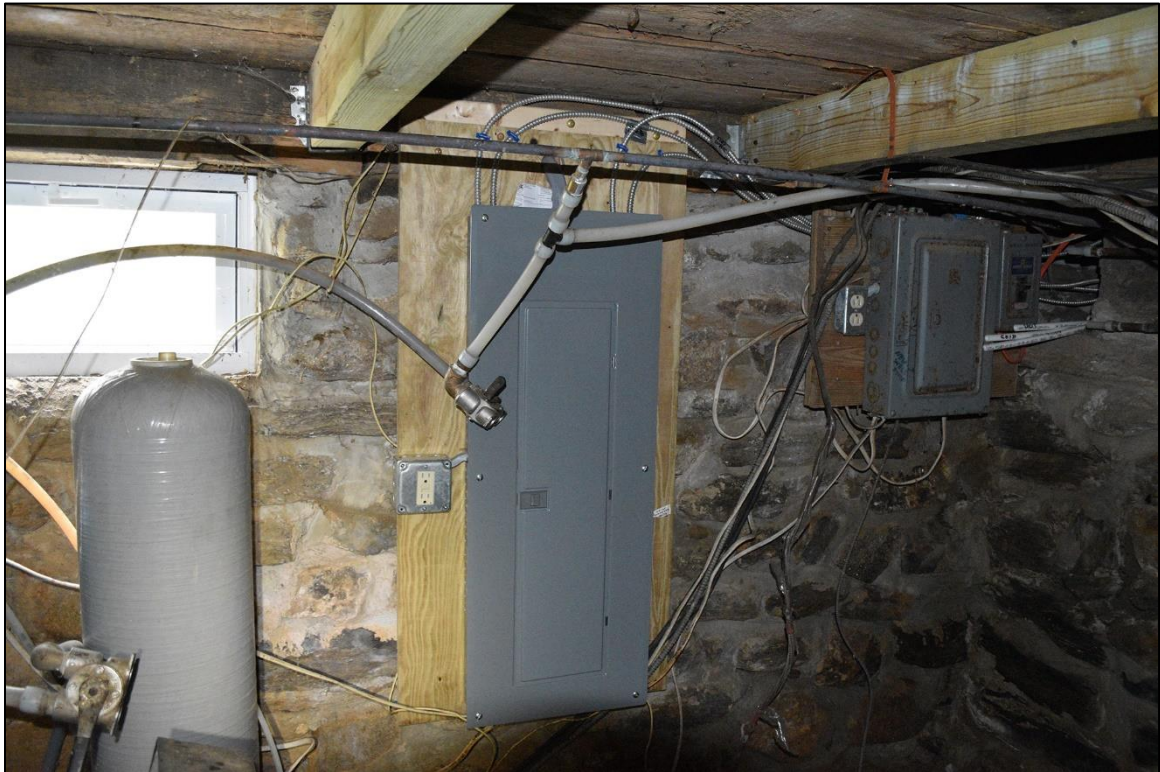
- Electrical: At the time of the site-visit, the electricity to Ash Cottage was shut off. The electrical service to the building is fed overhead from a pole near the garage. Though the old circuit-breaker electrical panel in the basement was recently replaced with a new panel, the majority of the interior wiring has yet to be transferred over to the new panel and the new panel was not switched on due to the proximity to the building's water circulation tank (Figure 55).

*Figure 55: Electrical panels, west basement wall*
