# **Historic Building Assessment for The Audubon Society of New Hampshire's Ash Cottage**

**50 North Shore Road, Hebron, New Hampshire**

Completed December 10, 2021

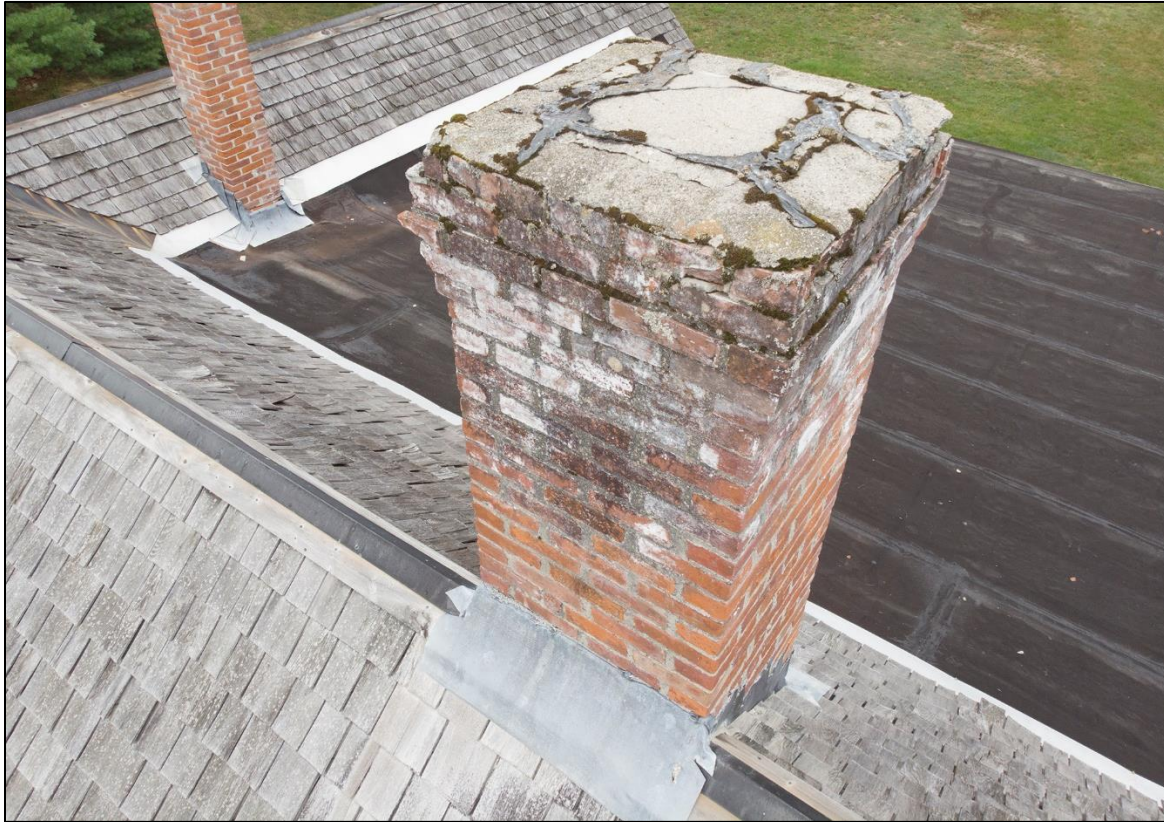
*Figure 13: Central chimney at main block, facing southeast*

The south slope of the main block is pierced by a brick chimney (Figure 13). The top of the chimney is plugged with concrete. Sections of this chimney appear to have been repaired. There is lead flashing along the east and west sides of the chimney, and copper flashing at the south side, placed on top of the wood shingles.

Sections of the main chimney appear to have been patched, as there are several different colors of mortar and brick visible from the exterior. There are some significantly spalled sections of the chimney below the roofline, with large sections of brick having come loose inside the attic. The chimney is “plugged” at the top with what appears to be cement, which has cracked and is growing moss along the fissures (Figure 13). The cracks and biological growth may be the result of moisture that is trapped inside the unventilated chimney. The flashing around the base does not appear to leak, however, there is some visual damage to the flashing at the north side of the chimney.

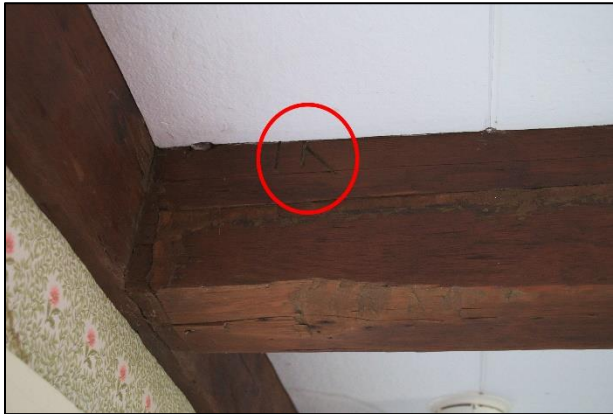
Figure 22: Roman numerals at ceiling joist

As mentioned in the architectural description, there are signs that there was once a fire in the historic kitchen, near the hearth. This damage is evidenced by scorching on the ceiling joists (Figure 23) and intermittent patches in the exposed first-floor framing (Figure 22).<sup>72</sup>

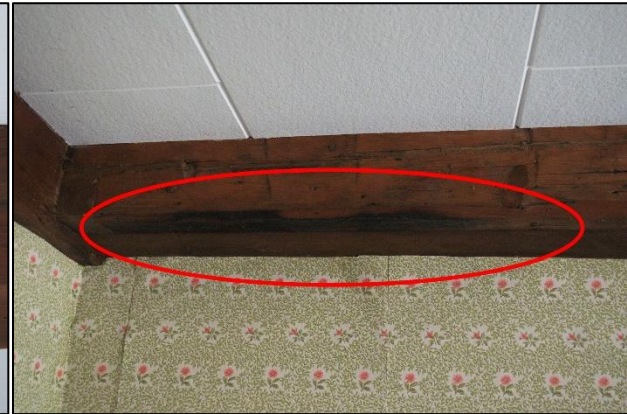
Figure 23: Scorched joist near original hearth

Several of the ceiling joists throughout the first floor appear to have been modified at a later date. There are some signs of scorching to the frame, particularly near what would have once been the kitchen hearth, and several of the ceiling joists throughout the first floor have sections on the underside that have been filled in with new material between the tenoned portions (Figure 23).

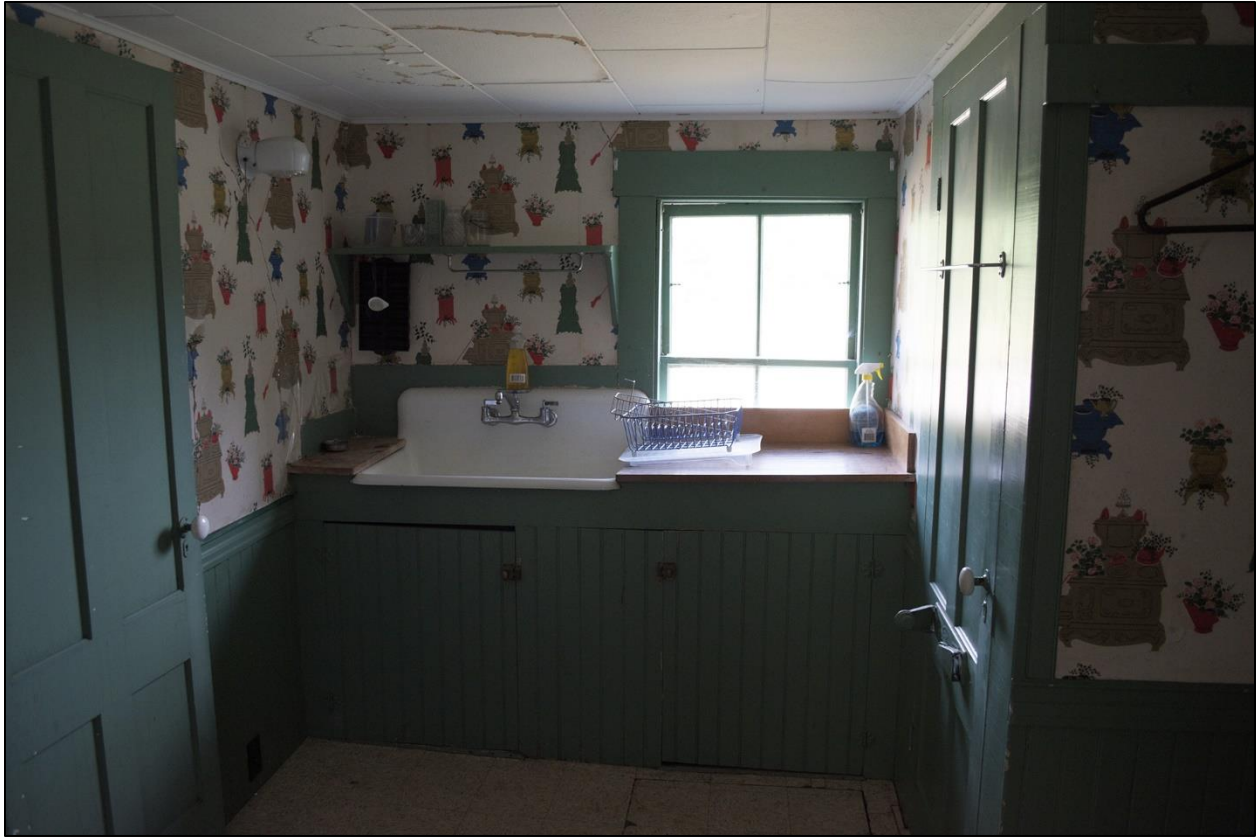
*Figure 31: East wing addition/kitchen, facing north*

- Walls/Ceilings: The walls and ceilings throughout Ash Cottage are a mixture of plaster and fiberboard. Generally, the walls are in good condition, however some significant cracks were observed in the plaster of the east wing addition (kitchen) (Figure 54). The nature of these cracks suggests that they may be stress cracks that were created when the foundation was repaired in 2019. The fiberboard ceilings are in good condition as well, with a few spots of staining in association with historic leaks (Figure 31).
